Operation **TEAPOT**

Project 35.1

EFFECTS OF ATOMIC WEAPONS
ON ELECTRIC UTILITIES

**EFFECTS OF ATOMIC WEAPONS
ON ELECTRIC UTILITIES**

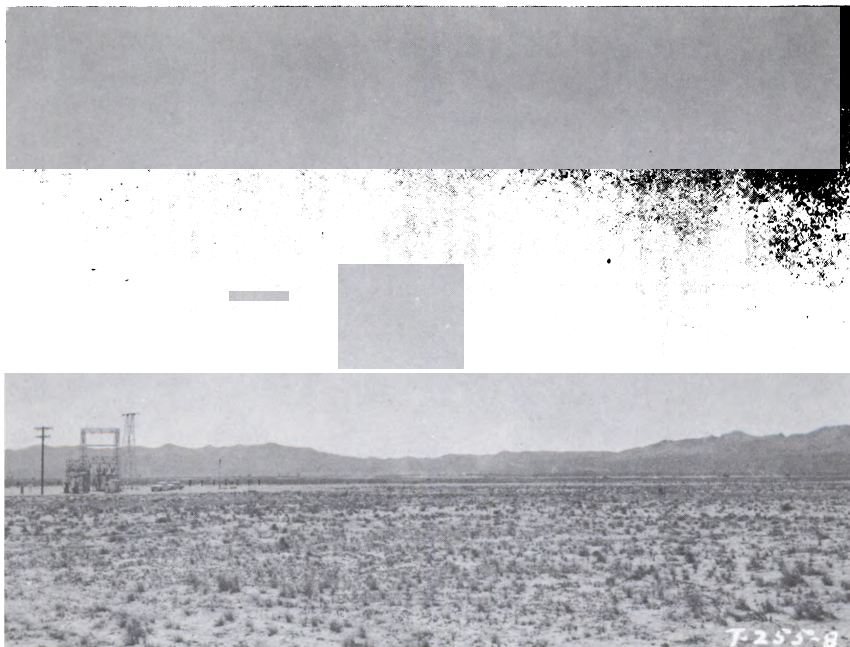
Fig. 3.1—Postshot view of the transmission line at the 4700-ft area.

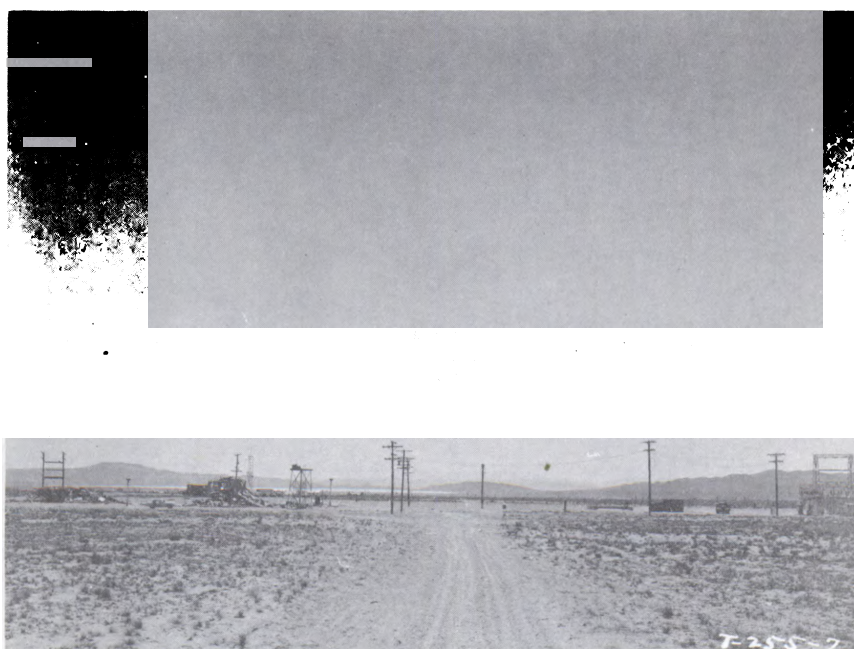
Fig. 3.2—Postshot view of the substation at the 4700-ft line.

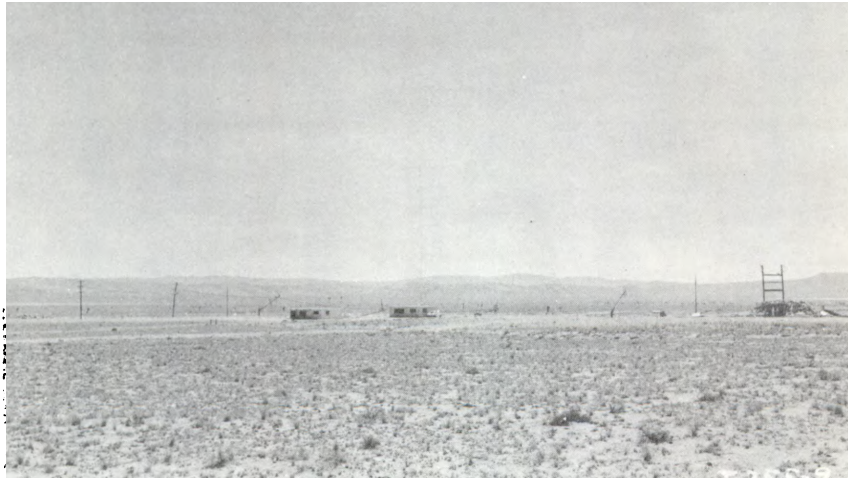
Fig. 3.3—Postshot view of the distribution circuit at the 4700-ft line.

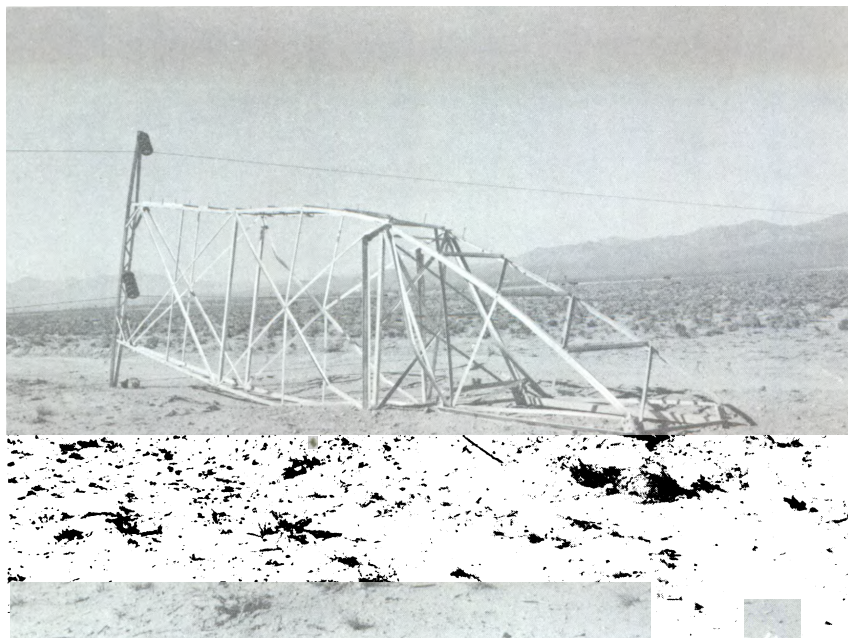
The only damage was to the suspension tower, which was blown over in a direction transverse to the transmission line (Fig. 3.4). The leg angles bent at the splice plates, which fastened them to the anchor stubs. The two leg members on the side of the tower away from the shot broke about 8 ft above the ground at a point where there were two $\frac{1}{2}$ -in. holes side by side on the 3-in. angle member. One insulator string was broken due to impact with the ground. The line conductors, splices, and hardware were undamaged.

Fig. 3.4—Structural failure of the suspension tower at the 4700-ft line.

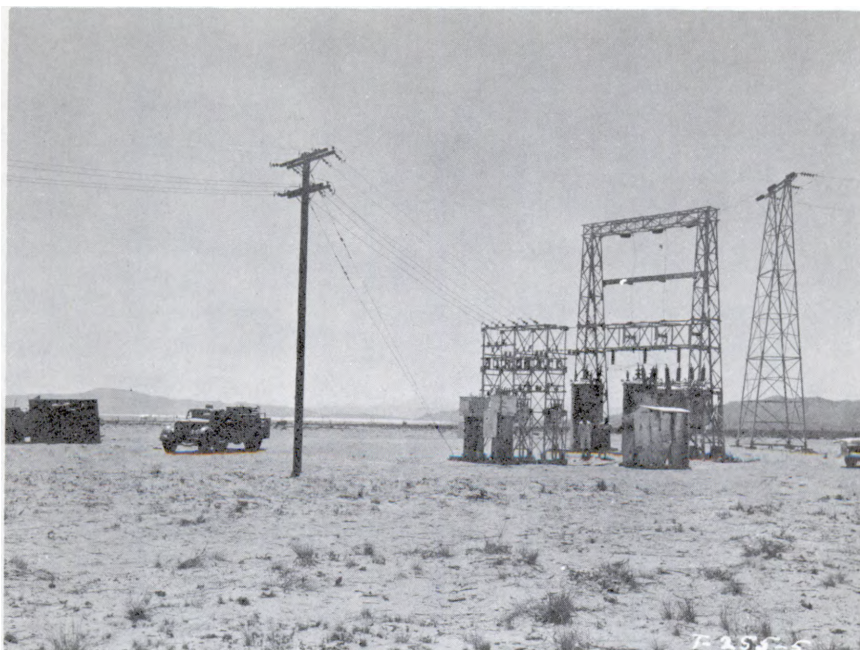
The steel dead-end structure supporting the 69-kv insulators, disconnects, and buses received minor structural damage (Fig. 3.5) in that two leg angles were slightly buckled at a point 3 ft above the foundation where several unused bolt holes were located.

Fig. 3.5—Postshot view of the substation at the 4700-ft line.

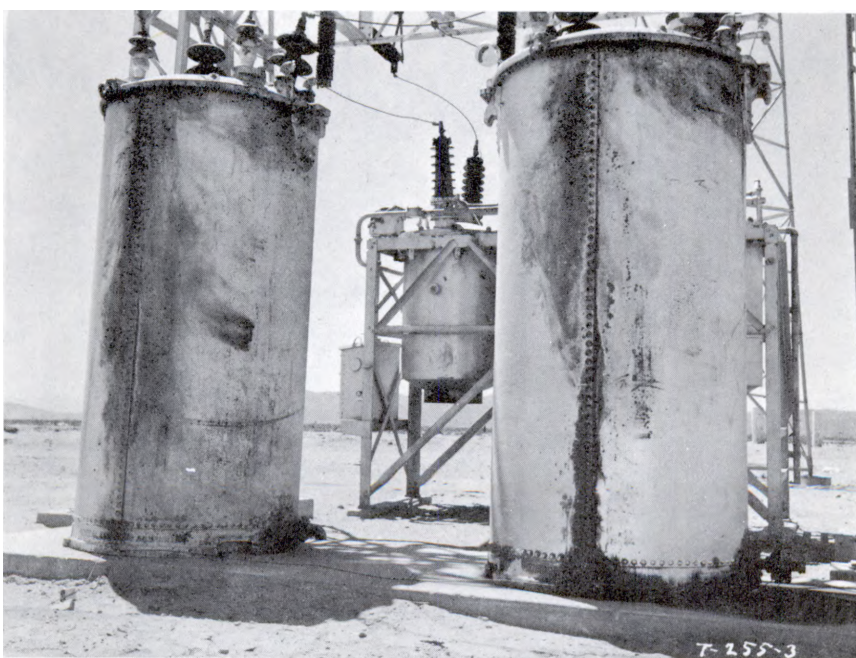
The two 1500-kva 69/11-kv transformers were undamaged and were not moved on the foundation pad. They later withstood a 30-kv a-c high-potential test to ground. The turn ratio between windings tested satisfactorily; and when meggered they gave the same values as was found in the pre-shot tests. The paint on the side of the case facing the blast was slightly blistered (Fig. 3.6). Neither the temperature nor the oil-level gauges were damaged.

Fig. 3.6—Thermal effect on the power transformer at the 4700-ft line.

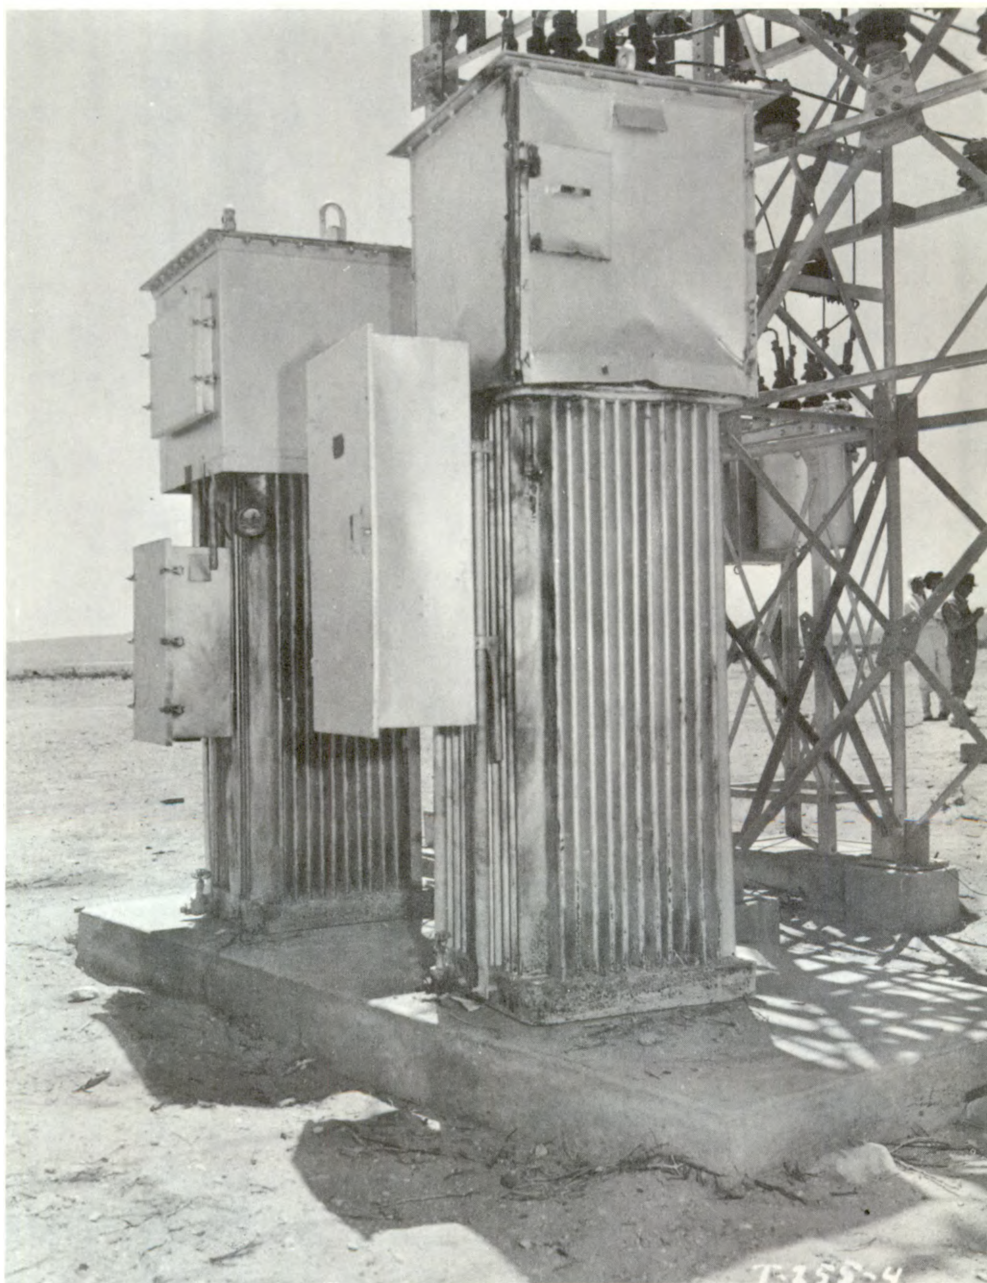
The two 4-kv 200-amp induction regulators were shifted on the foundation pad sufficiently to break electrical connections to the bus. In addition, the square flat-surfaced housing at the top of one regulator was dished on all four faces (Fig. 3.7). The flat-faced temperature-gauge glass was broken. The cylindrical oil-level gauge was not broken.

The regulators were tested and found to be electrically operative, but the raise and lower mechanism on one regulator was temporarily jammed. After approximately four operations of the raise and lower contactor, the mechanism was moving freely and was operating efficiently.

Fig. 3.7—Displacement of induction regulator and thermal effect on it at 4700 ft from GZ.

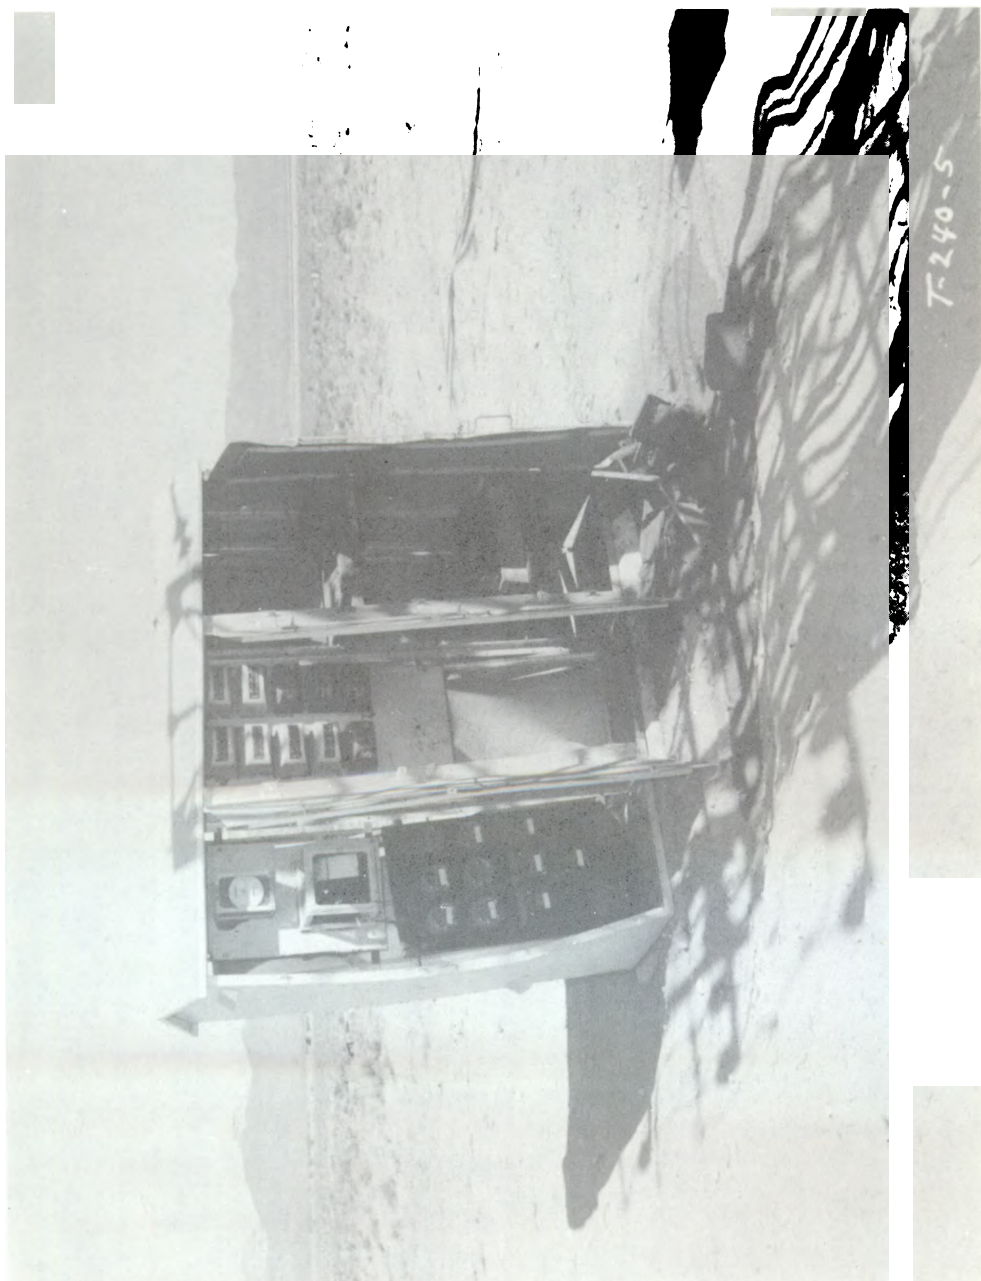
The three-compartment metal cubicle that housed meters, batteries, and instruments was severely damaged. The foundation pad to which this structure was bolted was noticeably tilted. See Fig. 3.8.

The battery cells were completely destroyed. All the glass cells were broken, acid was spilled over the ground, and most plates (both positive and negative) were damaged beyond repair.

The relays, instruments, and meters were tested identically to preshot tests and were found to be undamaged except for a broken cover glass on the recording wattmeter.

Fig. 3.8—Damage to the relay cubicle at 4700 ft from GZ.

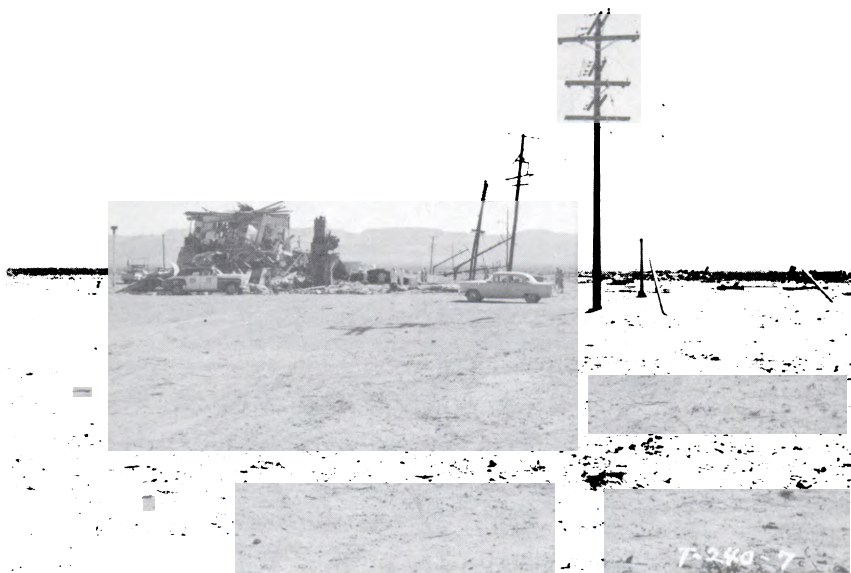
The distribution system sustained light to moderate damage. Of the poles in 14 positions, 5 were not damaged, 3 were very slightly damaged (to the extent of broken insulator pins on the 4-kv circuit only), 2 were extensively damaged, and 4 were down. No 11-kv metal insulator pins failed; and, except for down poles, the 11-kv circuit could have been reenergized. Slight scorching occurred to poles and crossarms. See Figs. 3.9 and 3.10.

Fig. 3.9—Failure of the distribution circuit at the rear of the 4700-ft property line.

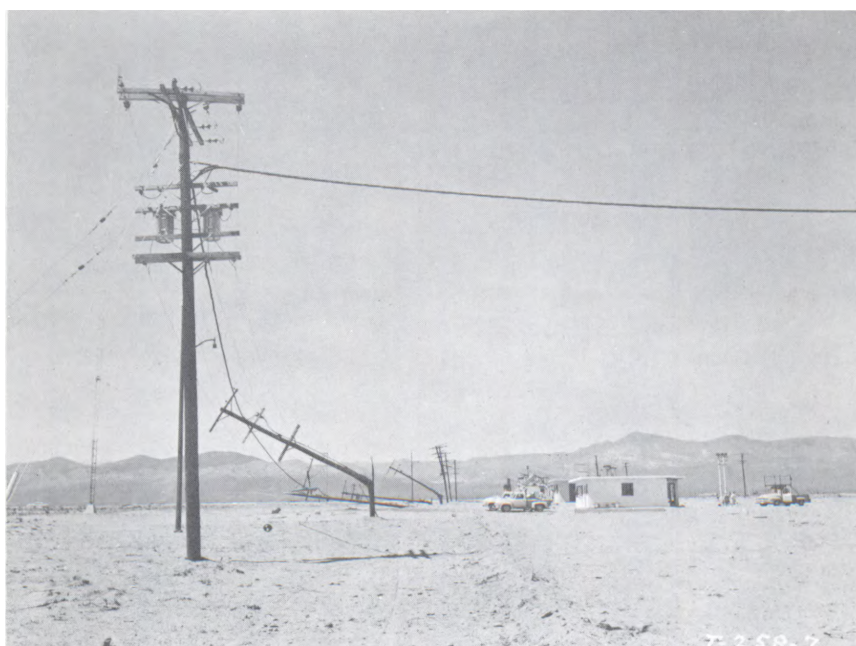
Fig. 3.10—Damage to pole 12 at 4700 ft from GZ.

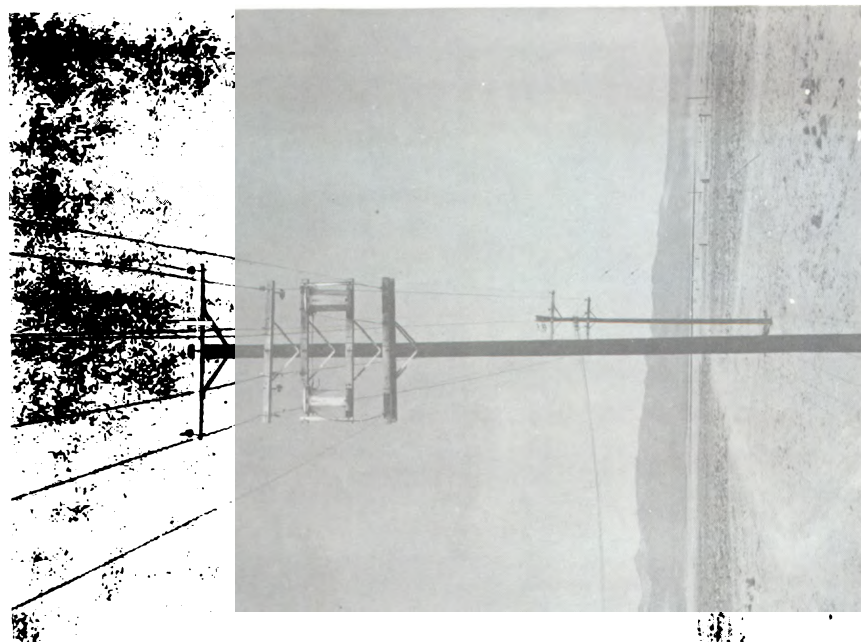
Pole 1 sustained one missing 11-kv insulator, but the pin was still in place in the crossarm. Poles 2 and 3 were undamaged. Pole 4 had two 4-kv wood insulator pins sheared and one pulled out of crossarm. The two 10-kva transformers were in place and undamaged although the crossarm on which they were hung was badly cracked. See Fig. 3.11. Pole 5 was undamaged. On pole 6 the 11-kv circuit was intact, but the 4-kv and secondary crossarms were splintered, apparently by house missiles. The 15-kva transformer was knocked to the ground at a distance of 36 ft from the pole. See Fig. 3.12. On poles 7A and 7B, the 11-kv circuit was intact, but four of the 4-kv wood insulator pins sheared, and two others pulled out. The crossarms were undamaged. The poles were displaced 4 in. at ground level and were leaning away from the blast due to the weight of adjacent down poles. See Figs. 3.13 and 3.14. The three 50-kva platform-supported transformers were blown to the ground, apparently by blast and missiles from the houses. See Fig. 3.15. The crossarms were undamaged. Pole 8 broke about 8 ft above ground level. The top portion leaned 60° from the vertical. One wood pin sheared on a 4-kv crossarm in the 4-kv circuit. The pothead was undamaged; the riser pipe bent, but the cable was undamaged. Secondaries between poles 7b and 8 snapped at the insulators on pole 8. See Fig. 3.16. Pole 9 broke at ground level, but the 11-kv circuit was intact. No damage was noted to the crossarms, capacitors, or insulators. The aerial cable was unbroken from pole 9 to pole 14. See Fig. 3.17. Pole 10 broke 1 ft below ground level. A 15-kva transformer was knocked to the ground and broken. The top of pole was split. The 11-kv crossarm was not broken but was separated from the pole. One 11-kv insulator was broken. The crossarm supporting the aerial cable was separated from the pole but was held on by the braces. One 11-kv conductor (#2/0 ACSR) was frayed and cut in half by the radio-tower guy wire on which it fell. See Figs. 3.18 and 3.19. Pole 11 was broken 8 ft above the ground. One 11-kv insulator was broken. The riser pipe was bent, but the pothead and the aerial cable were not damaged. See Fig. 3.20. Pole 12 was undamaged; the two 10-kva transformers remained in place and were not damaged. The pole bent about 5° in the direction of the downed poles. Pole 13 had one 11-kv insulator missing. The mast arm of the luminare was deflected about 10°. The globes, which were elliptically shaped, were not broken. Pole 14 was not damaged. The mast arm of the luminare was deflected about 10°, but the elliptical globes were not broken.

Fig. 3.11—Damage to pole 4 at the 4700-ft line.

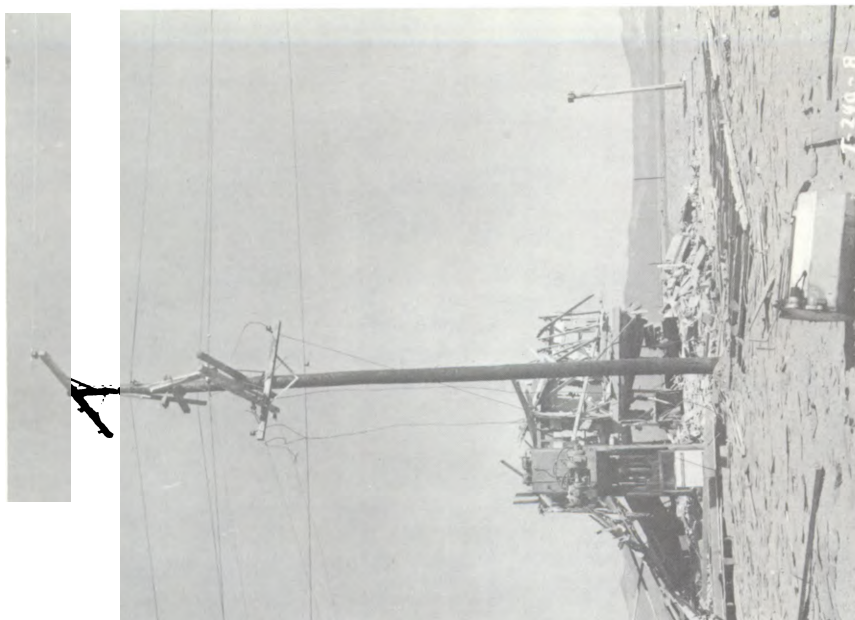
Fig. 3.12—Damage to pole 6 and transformer at the 4700-ft line.

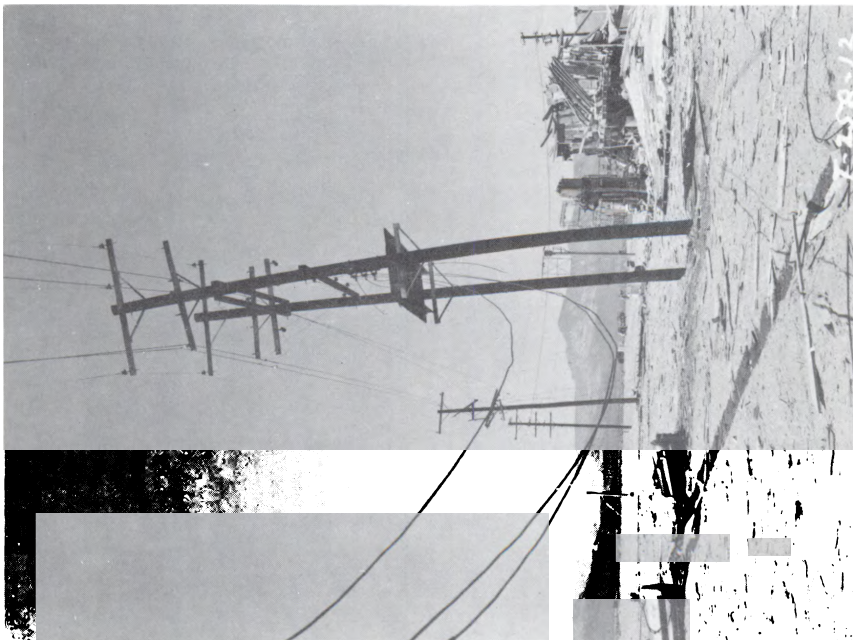
Fig. 3.13—Damage to poles 7-A and 7-B at the 4700-ft line.

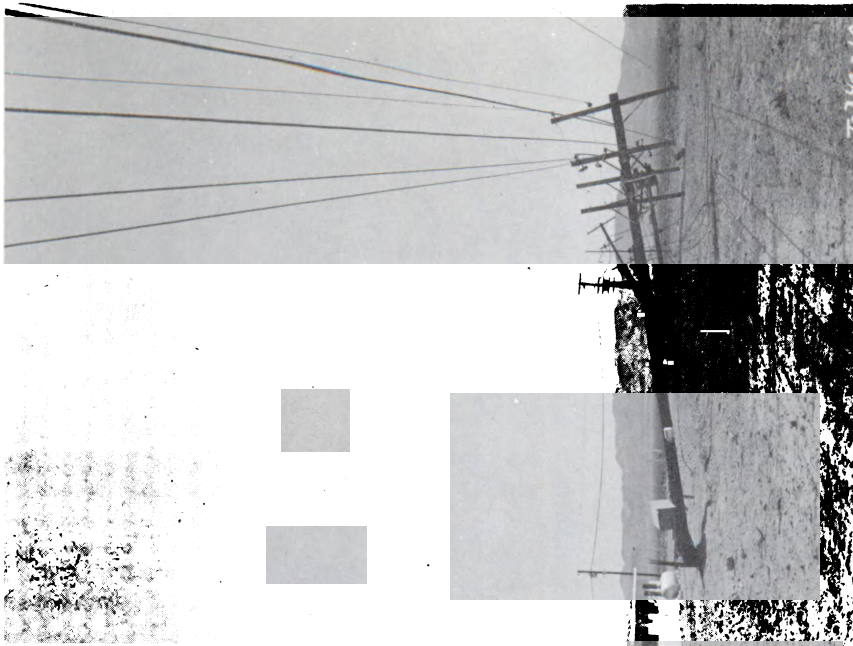
Fig. 3.14—Damage to distribution poles at the 4700-ft line.

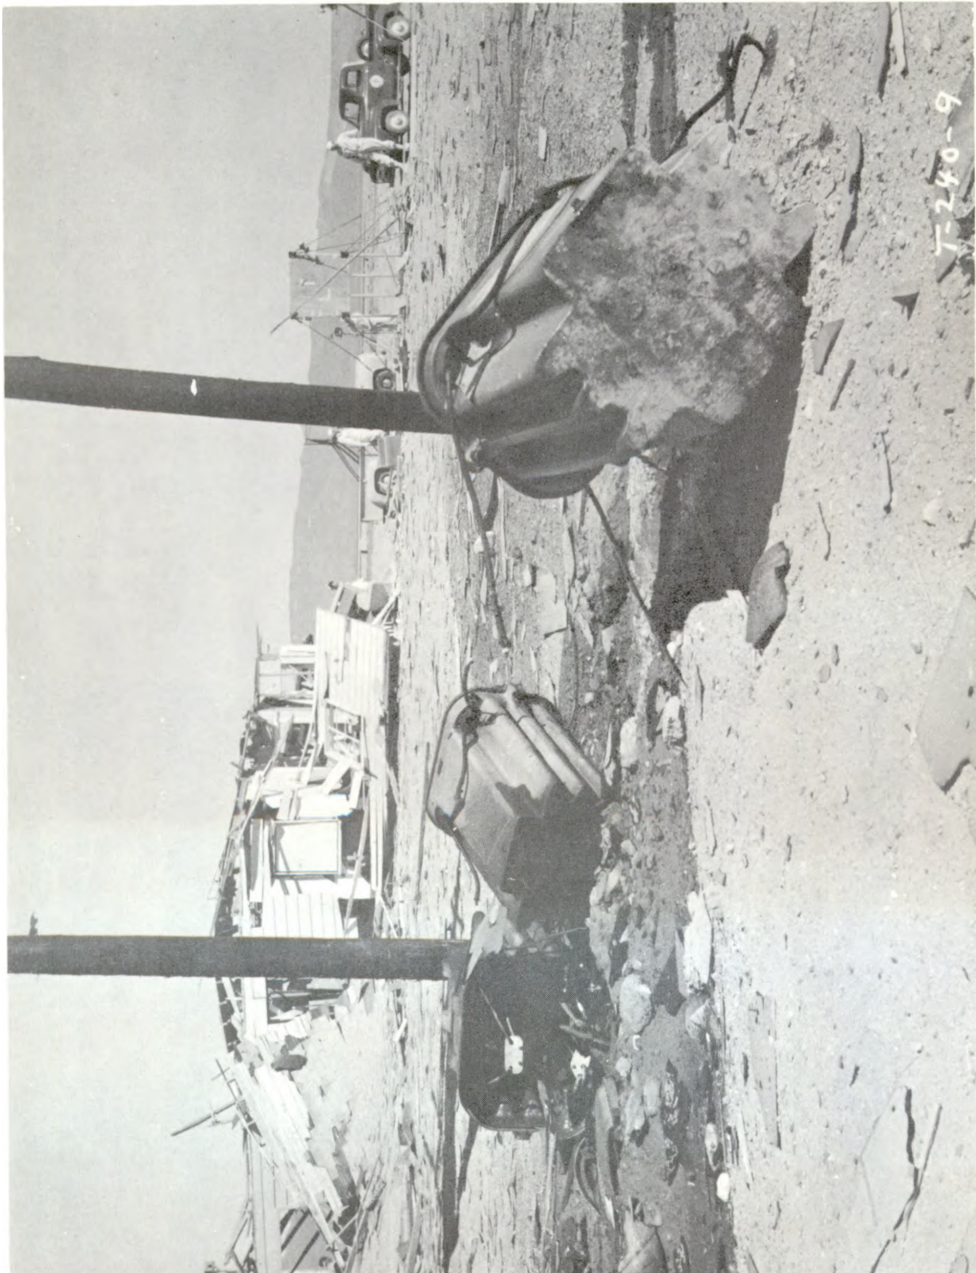
Fig. 3.15—Damage to transformers mounted on platforms at the 4700-ft line.

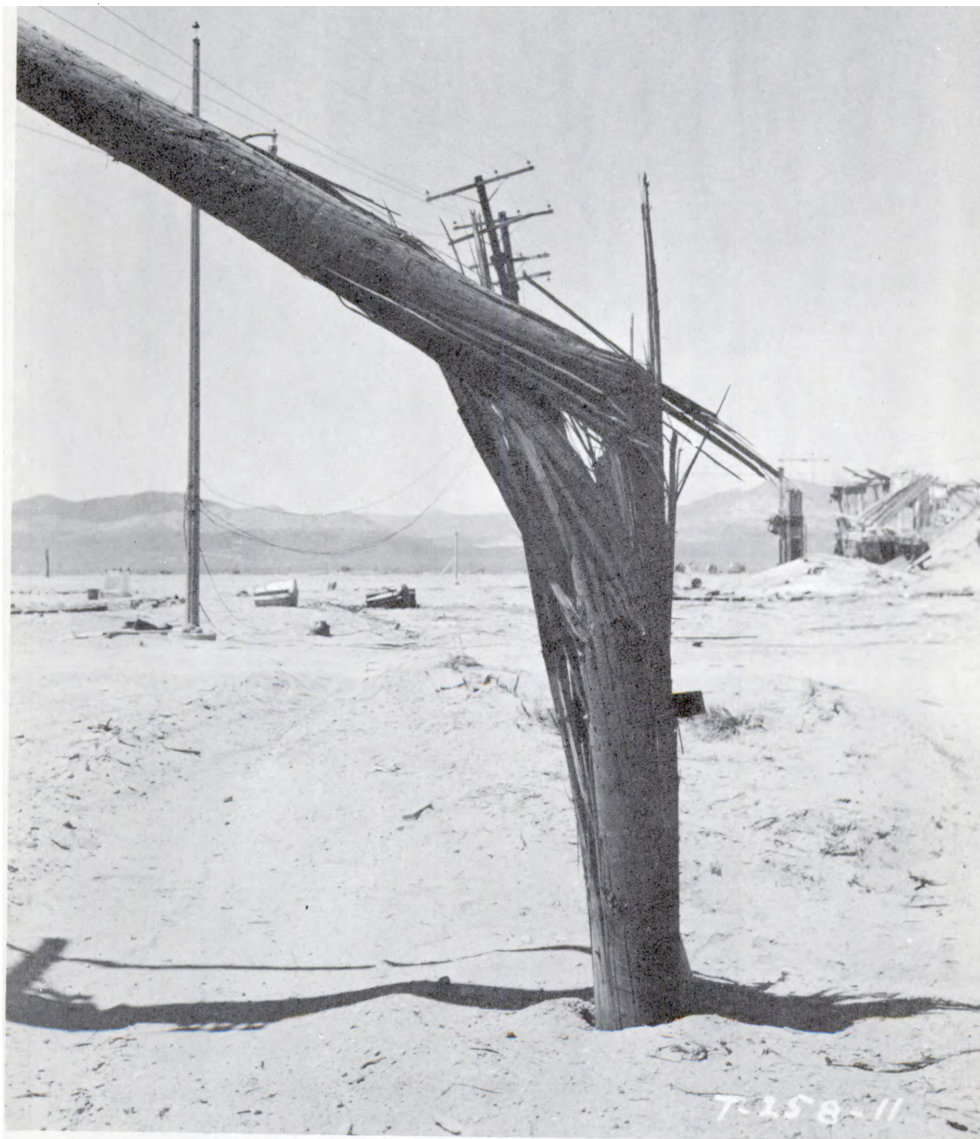
Fig. 3.16—Damage to pole 8 at the 4700-ft line.

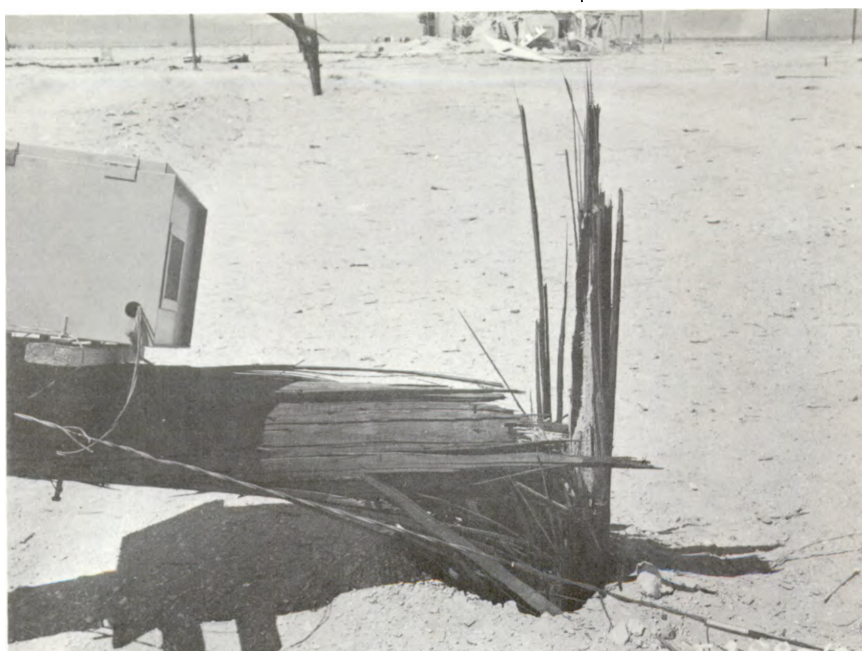
Fig. 3.17—Damage to pole 9 at the 4700-ft line.

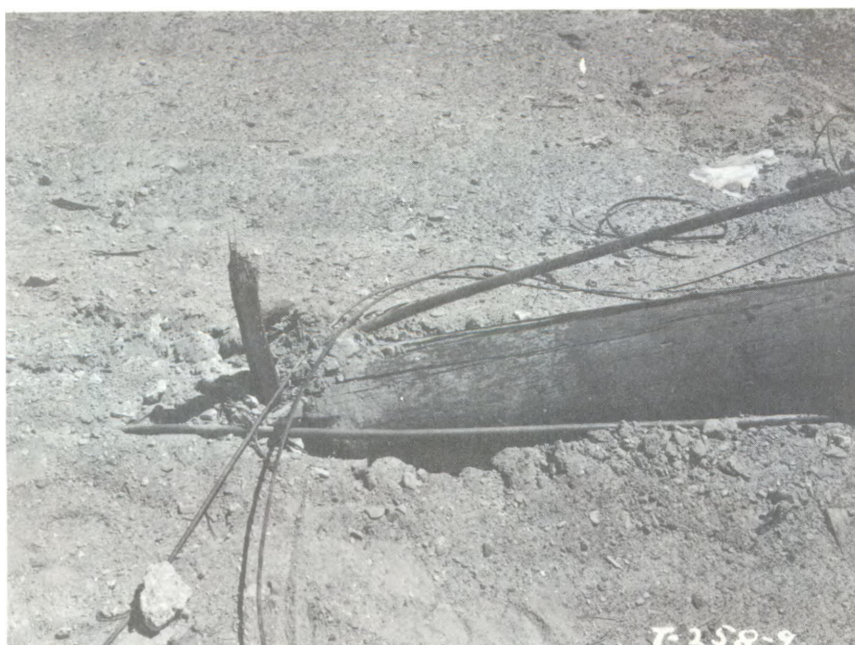
Fig. 3.18—Damage to pole 10 at the 4700-ft line.

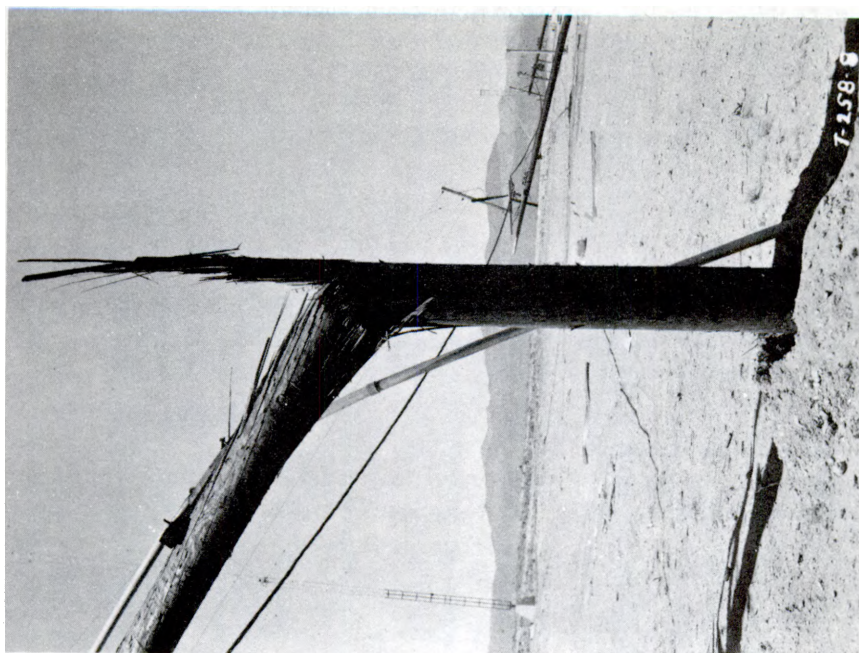
Fig. 3.20—Damage to pole 11 at the 4700-ft line.

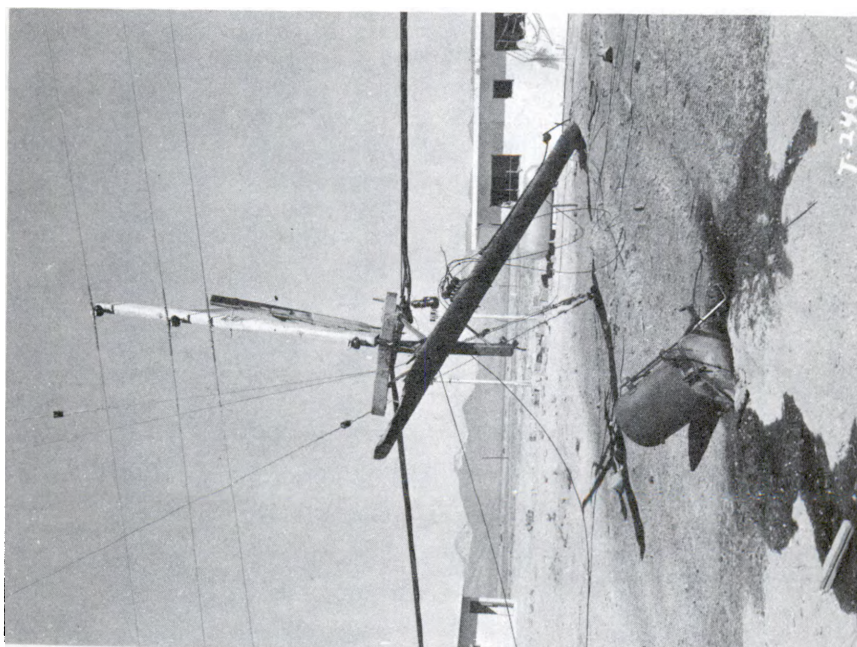
Fig. 3.19—Damage to transformer at the 4700-ft line.

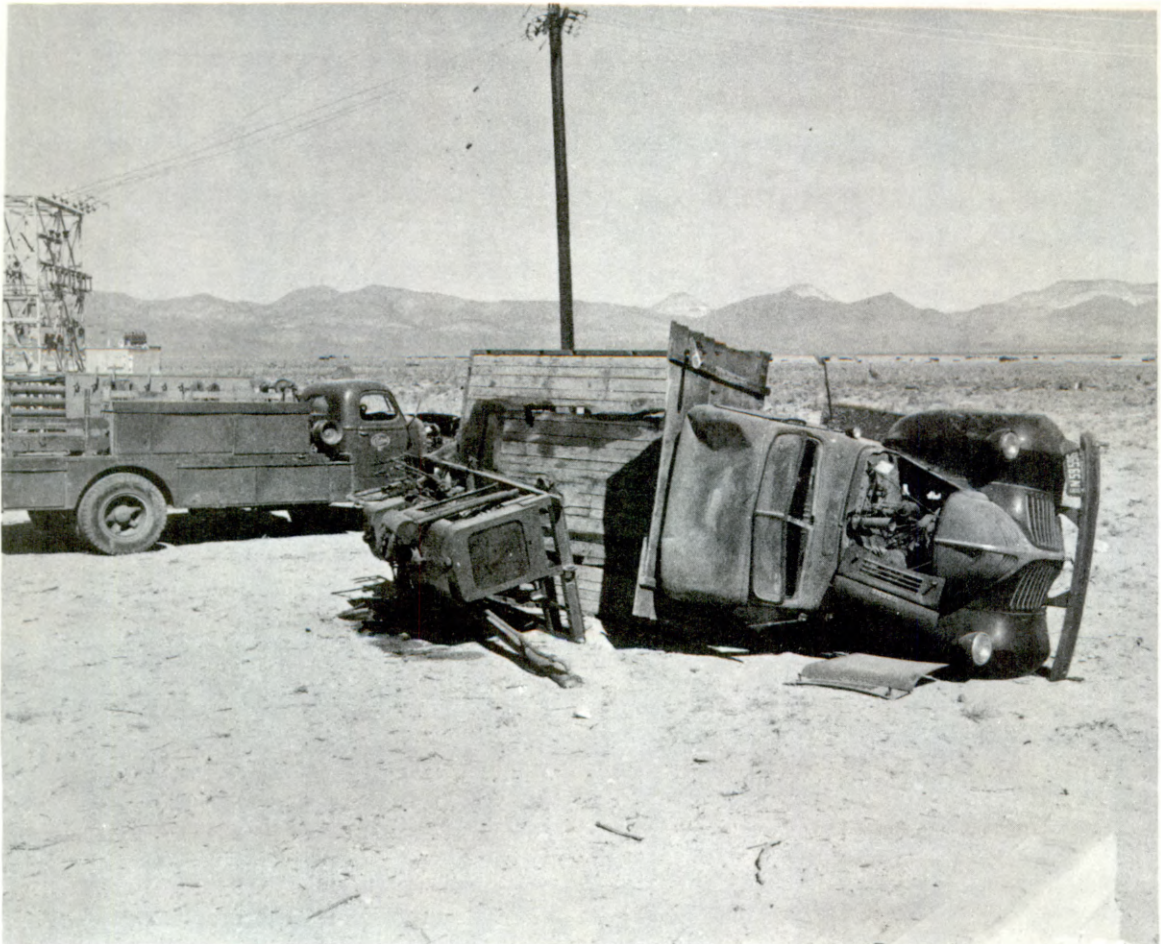
The truck that was equipped with an earthboring machine (also exposed in Project 36.2) tipped over, sliding the boring machine to the ground (Fig. 3.21).

Fig. 3.21 — Damage to service vehicles at the 4700-ft line.
